State of Nevada  
Department of Agriculture  
Agriculture Headquarters Office  
Facility Condition Analysis

# AGRICULTURE HEADQUARTERS OFFICE

405 South 21<sup>st</sup> Street  
Sparks, Nevada 89431

**Site Number: 9868**  
**STATE OF NEVADA PUBLIC WORKS DIVISION**  
**FACILITY CONDITION ANALYSIS**

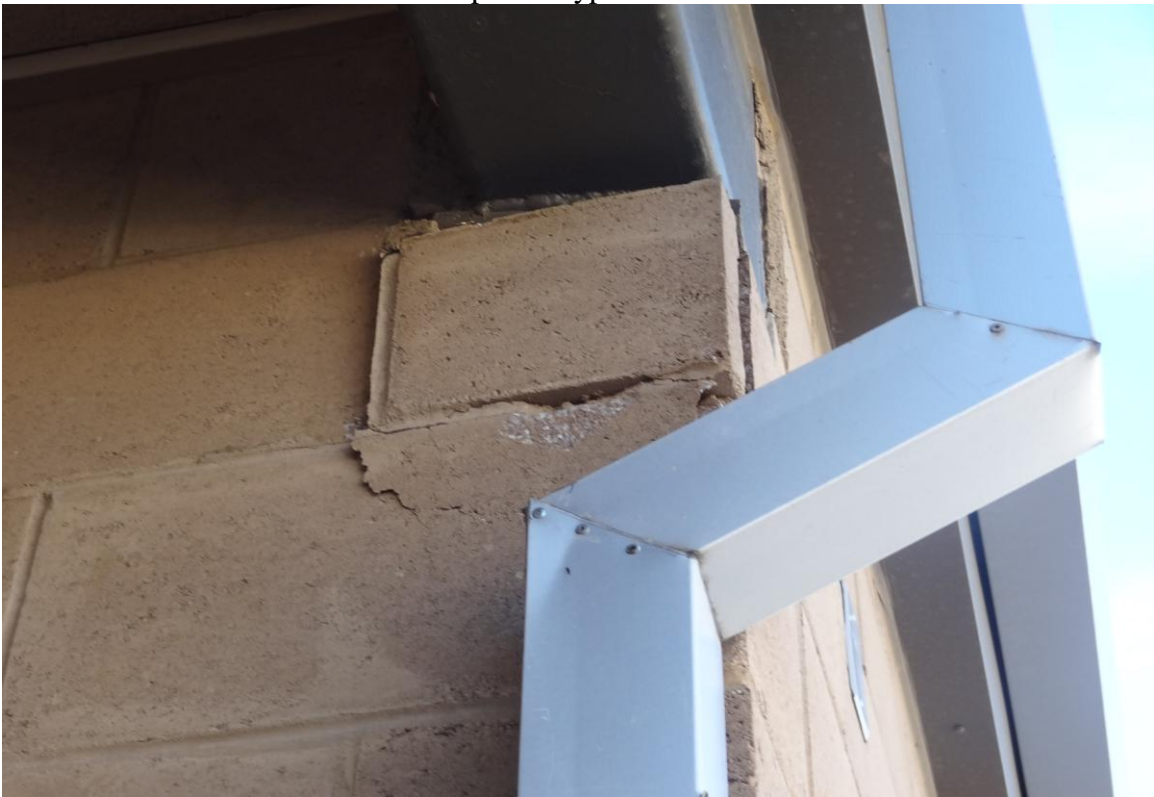
Headquarters & Lab – FCA Building #2989  
Description: Exterior CMU damage.

It is important to maintain the finish, weather resistance and appearance of the building. This project would provide funding to protect the exterior of the building excluding the roof. Included in the cost are cleaning and sealing the concrete masonry units and caulking of the windows, flashing, fixtures and all other penetrations. It is recommended that the building be sealed and caulked in the next 2-3 years and that this project is scheduled on a cyclical basis to maintain the integrity of the structure.
